NONDESTRUCTIVE EVALUATIONS OF COM-  
POSITE HEATSHIELD MATERIALS BEFORE  
AND AFTER AN UNDERGROUND NUCLEAR  
EXPOSURE

Southern Research Institute

Air Force Weapons Laboratory

AFWL-TR-73-247

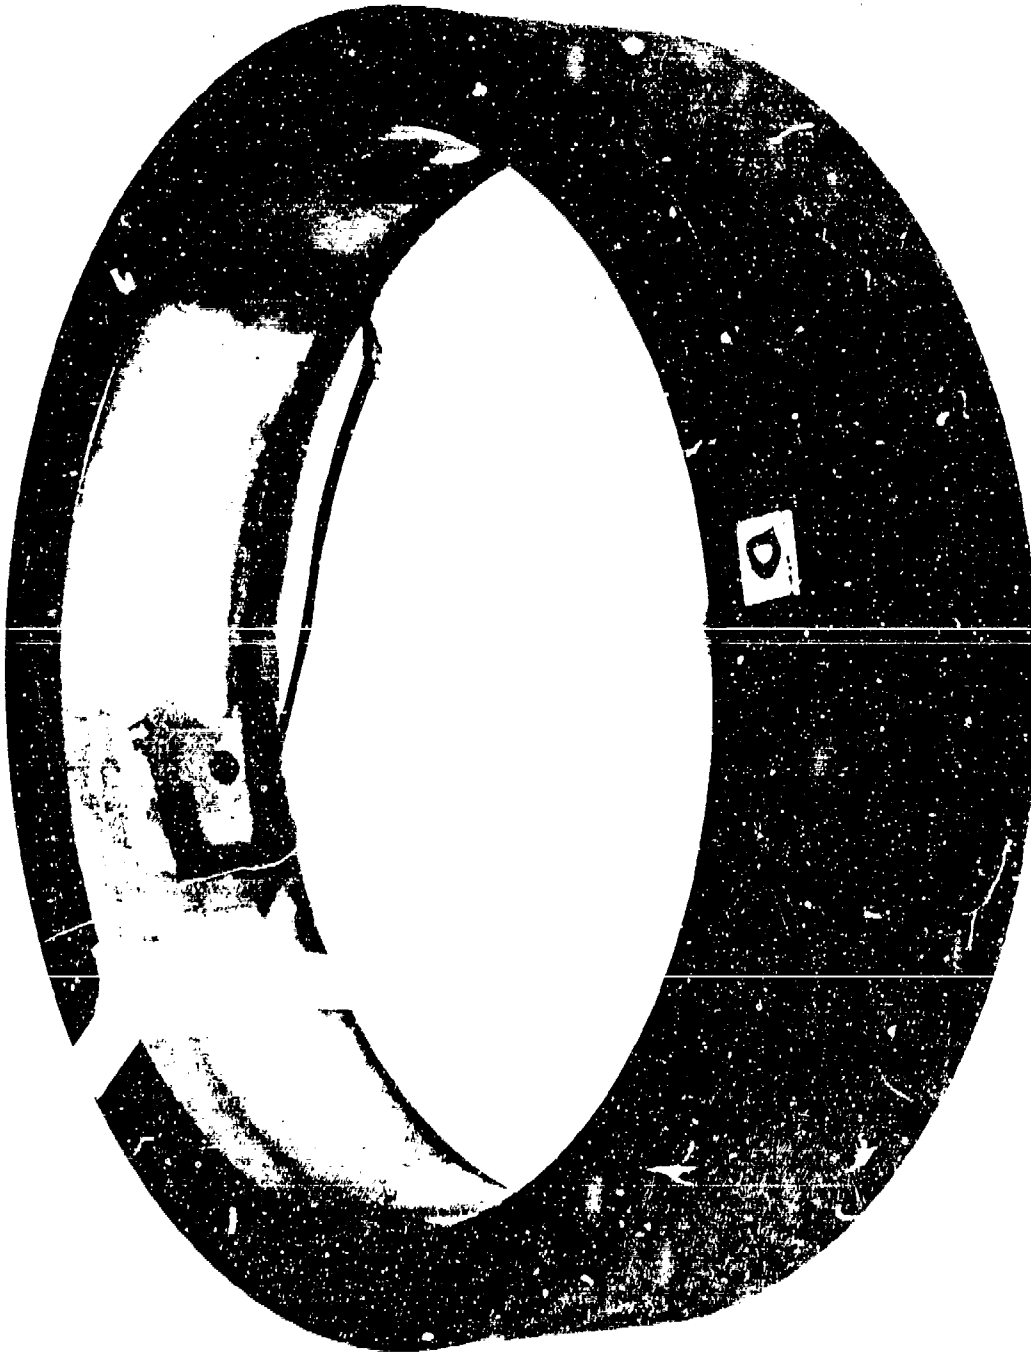
Figure 40. Photographs Showing As-Received Ring 9N-2 from Sandia Felt CC  
After Exposure

No really significant structural change such as cracking was detected in these two rings. Photographs showing the rings as-received are given in Figures 40 and 41. For 9N-2, the only changes or noteworthy observations were that the exposed-zone segment of the bottom edge was slightly more porous, Figure 42a, and the exposure-zone outer surface (front face) was slightly discolored (dark) and rougher in texture, Figure 42b and c. For 9P-2, change and noteworthy observations were discoloration (dark) on top edge, 80 mil chip in top outer edge at 315°, higher porosity in exposure-zone of bottom edge, 20-mil voids in bottom edge at 240 - 255° and 270°, and material removal and discoloration in exposure-zone front face. These changes are detailed in Table 6 and depicted in Figure 43. Axial X-ray and liquid penetrant inspection did not reveal any structural change in these rings.

b.  
(No Scale)  
Radial View - Outer Surface Near 0°

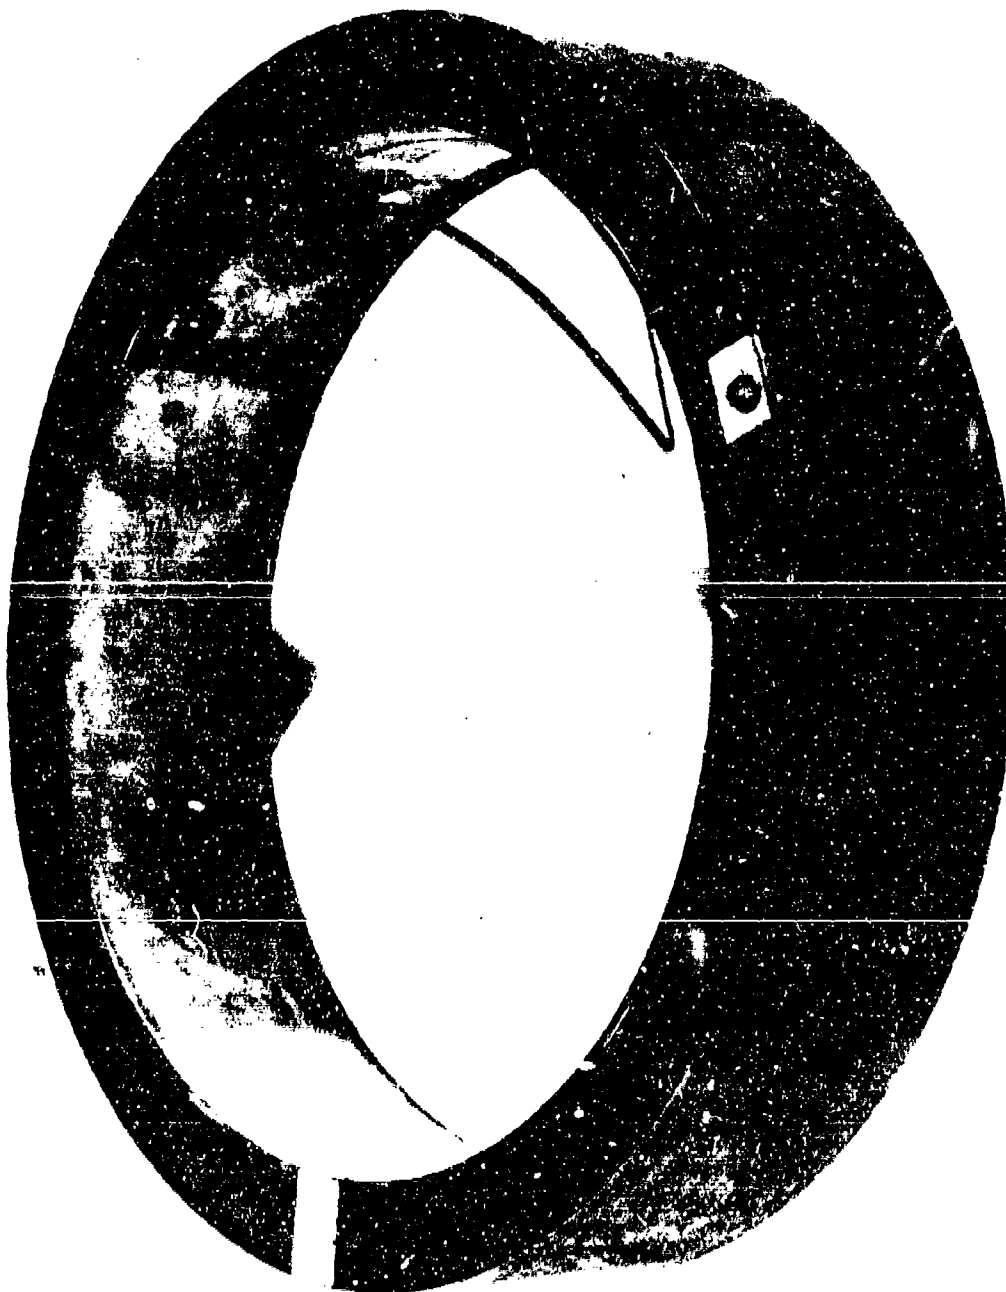
Figure 41. Photograph Showing As-Received Ring 9P-2 from Sandia Felt CC  
After Exposure

b.  
(No Scale)  
Radial View - Outer Surface in Exposed Zone
